# Manhole Inspection Summary

Manhole # S47Y1\_008MH

**Location** Address: **1301 Chesapeake Ave.**

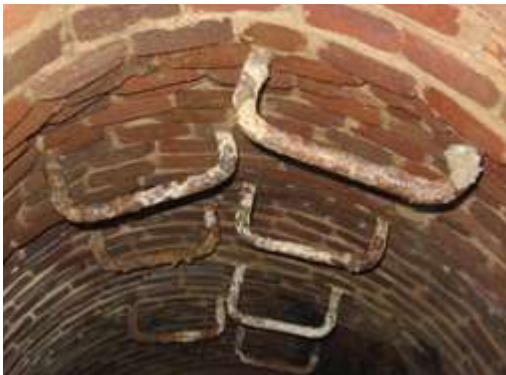
Steps

**Steps** Count: **7** Missing: **0** ☒ **Corroded**

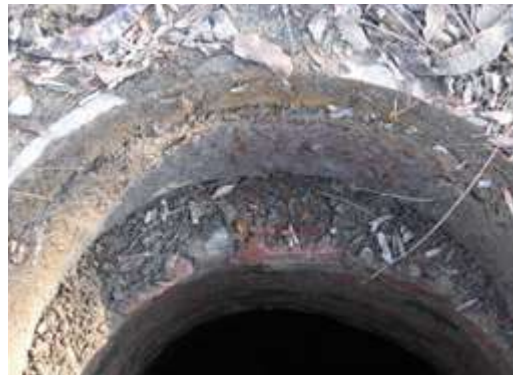
Defect 1

**Frame** Offset: **3** (in.) Condition: ☒ Sound ☐ Cracked ☐ Leaks

Frame offset.

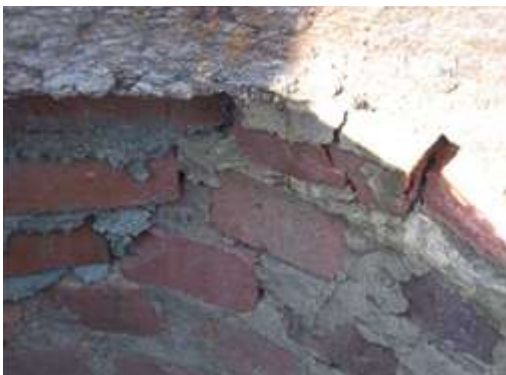
Defect 2

Condition: ☐ Sound ☒ **Cracked** ☐ Root Intrusion ☐ Loose Brick ☐ Deteriorated

Infiltration: ☐ None ☒ **Joint** ☐ Cracks ☐ Mortar ☐ Roots ☐ Wall

Cracked chimney.

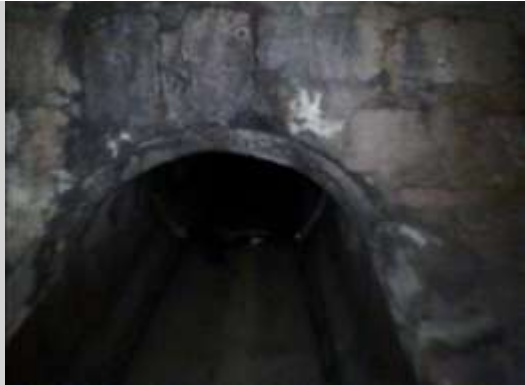
12 O'Clock Outflow

10 in. Circular Gravity Sewer  
Pipe Out @ 12 O'Clock

Pipe Height: **9.6** (in.) Rod and Bar (Angled)  
Pipe Material: **Clay** ☐ Pipe Lined  
Invert Depth: **12.88** (ft.) Flow Characteristics: **Fast**  
Deposits: ☒ None ☐ Mud ☐ Sludge ☐ Debris ☐ Grease  
Silt Depth: (in.) Deposits Extent:  
Infiltration: **None** Pipe Seal Cond: **Cracked**
